# **A Full-scale 3-floor Mock-up Toilet Experimental Research Facility:**

## **The Research Platform of Sanitation Hygiene and Environment (RPSHE)**

**Presented By Ir Dr L. T. Wong**

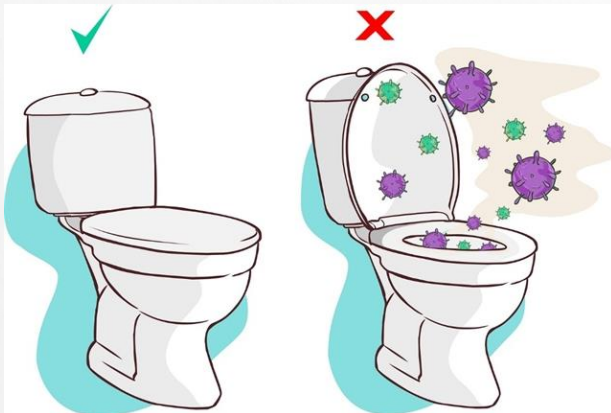
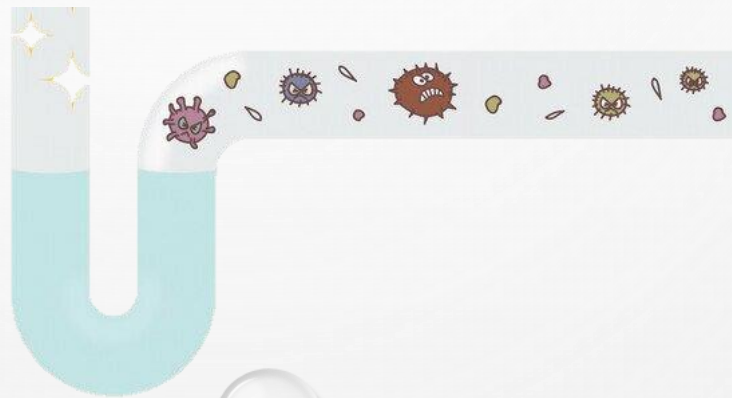
- Airborne diseases spreading through sewage system was first discovered in Hong Kong in 2003 during the outbreak of SARS
  - Super-spreading of the SARS virus through dried U-traps and leakage from the sewage vent pipe at 4/F of Block E of Amoy Garden was identified
- Vertical airborne transmissions of the SARS-CoV-2 induced by toilet ventilation and poorly maintained drainage system have been suspected to be responsible for many in-building outbreaks in Hong Kong

**Source from? WC flushing & via exhaust fan? Floor drain? ... Any others?**

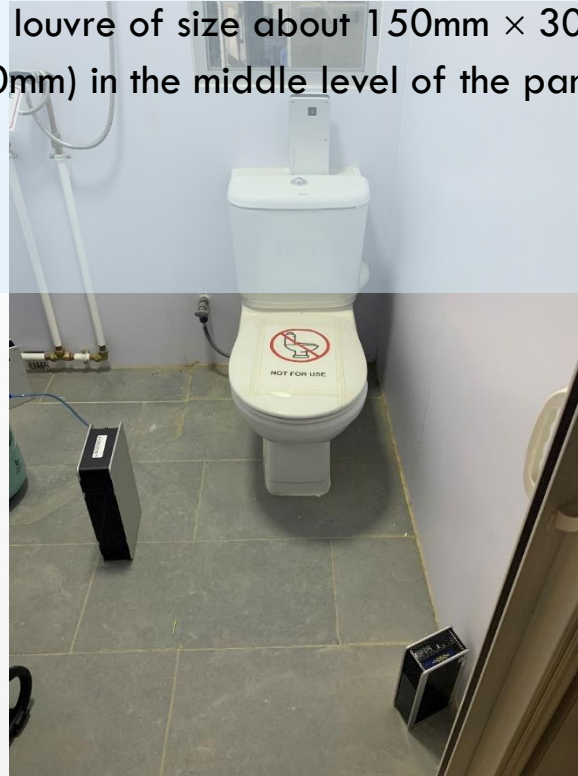
# A single-person toilet of public housing

- Water closet fitted with drainage pipe
- Wash basin fitted with U-trap & drainage pipe; drainage-ventilating pipe extended 1m above the top floor
- 6-inch exhaust fan with an air volume of 210m<sup>3</sup>/hr at a high level of one-panel wall
- Floor drain fitted with a drainage pipe & water seal
- A sliding door fitted with a low-level louvre of size about 150mm × 300mm
- An openable window (600mm × 900mm) in the middle level of the panel wall
- Lighting
- Electrical services

Building design and the service systems follow the Building Regulation Chapter 123I (Standards of Sanitary Fitments, Plumbing, Drainage Works and Latrines) in Hong Kong

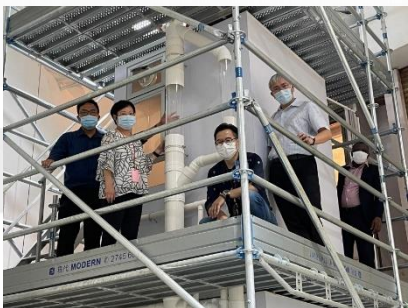
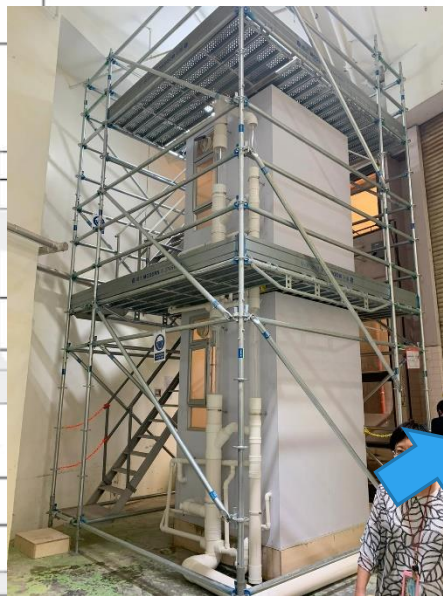
# The RPSHE facility

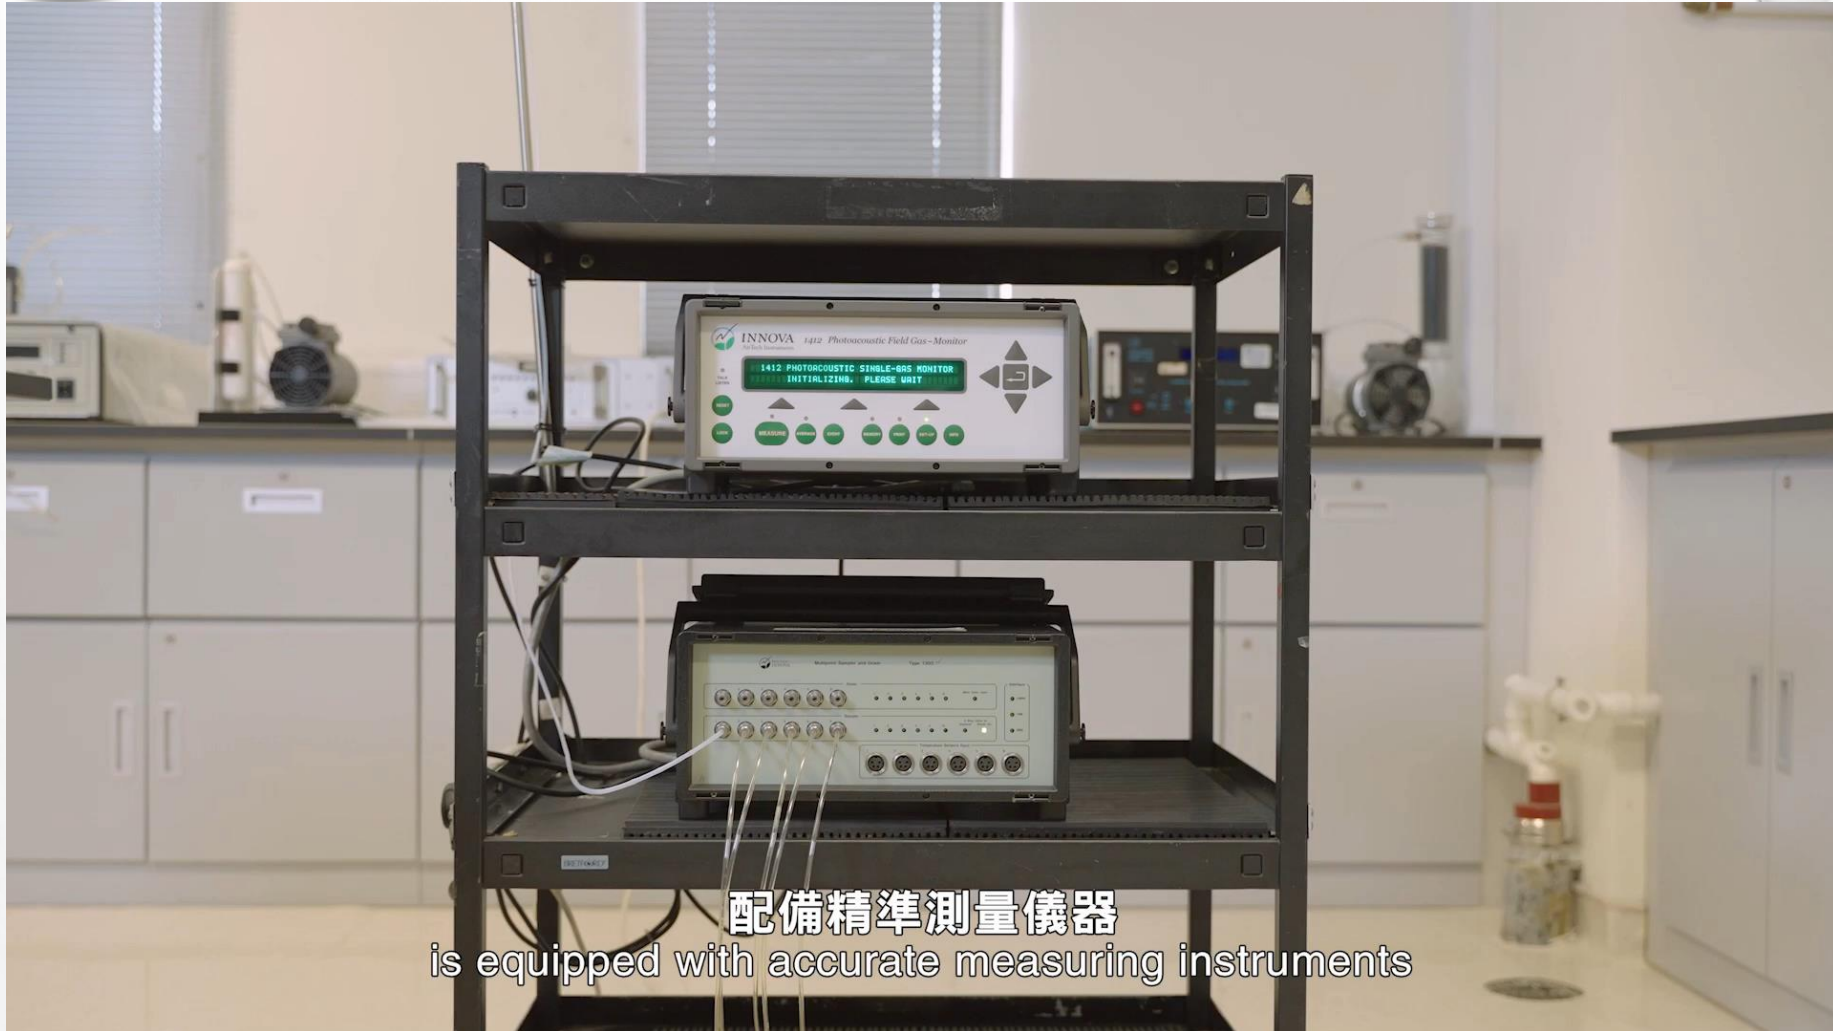
- Tracer gas experiments were conducted under different ventilation schemes to evaluate the ventilation performance of the toilet to identify the potential vertical airborne transmission routes through ventilation
- Tracer gas: **released inside the G/F toilet (Cases)**, well-mixed (by a fan)
- On the 1/F: **toilet door (CLOSE), exhaust fan (ON), window (OPEN)**
- Locations of tracer gas samplers
  - Inside the toilets on G/F and 1/F
  - Outside the toilets near the window side
  - At the roof
- Air change rate: the concentration-decay method:  $C(t) = C_0 \times e^{-\lambda \times t}$

# Set-up & Shows

Case	Door	Exhaust fan	Window	Air change rate (h <sup>-1</sup> )
1	Closed	Closed	Closed	1.2
2	Opened	Closed	Closed	14.1
3	Closed	Opened	Closed	3.5
4	Closed	Closed	Opened	3.5
5	Closed	Opened	Opened	24.3
6	Opened	Closed	Opened	31.4
7	Opened	Opened	Closed	26.7
8	Opened	Opened	Opened	33.6

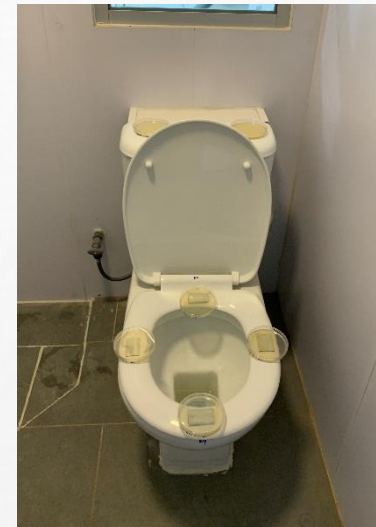
- Identification of transmission pathways within the bathroom environment and the drainage system
- Measurement of the air pressure & flow in/associated with the drainage pipes
